BROOKHOUSE

CONSERVATION AREA APPRAISAL

DECEMBER 2009

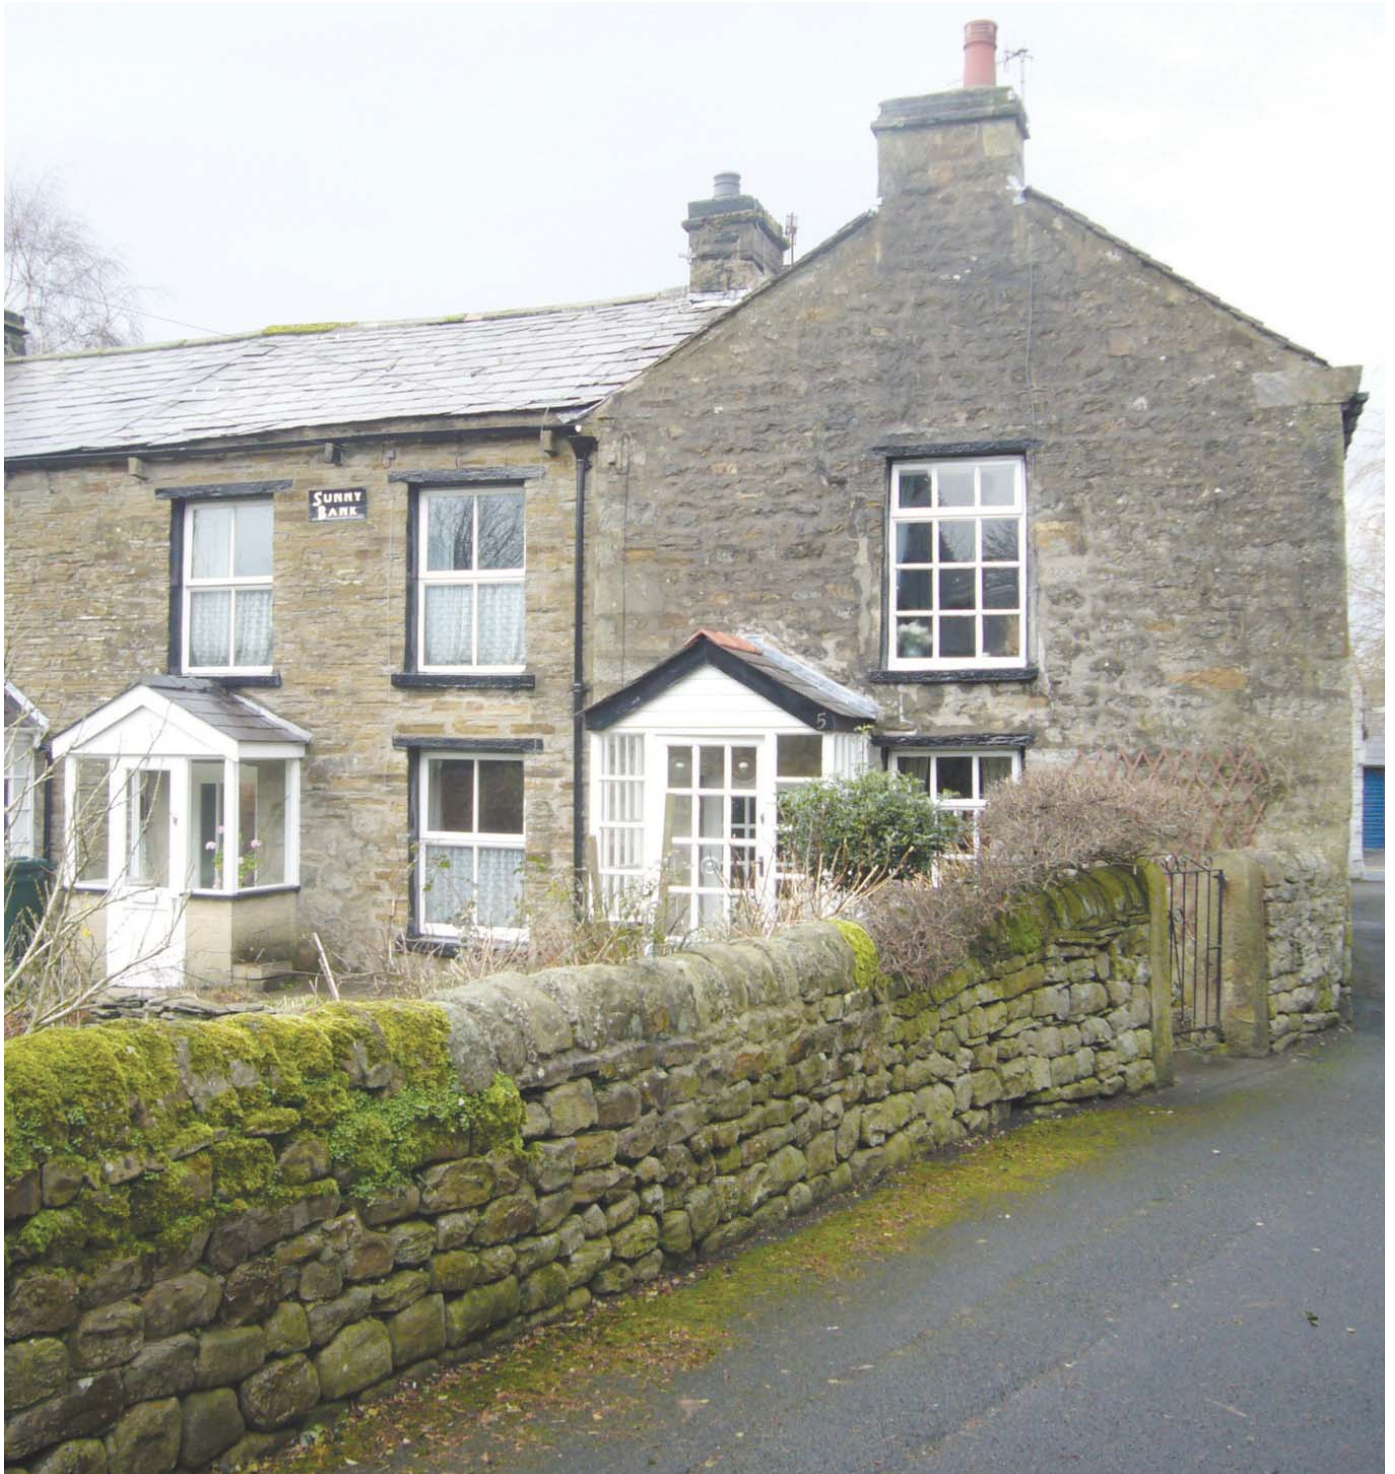
The geology is reflected in the buildings

- 2.8 The underlying solid geology of the area consists of carboniferous sandstone featuring Millstone grit.

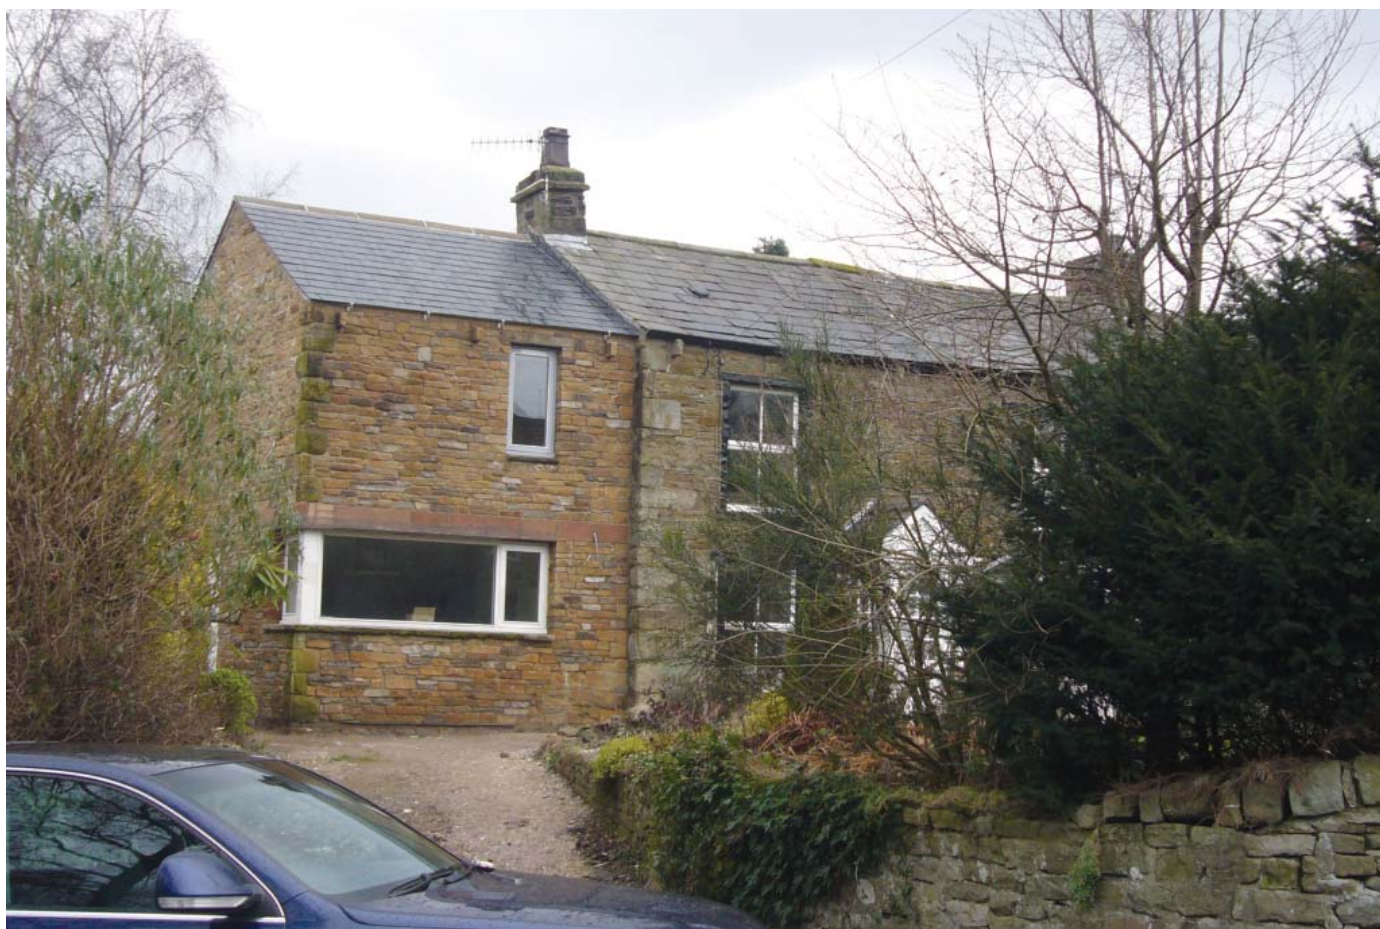
Non-traditional extension

- 6.2 In some cases, door and window openings have been altered, for example to create large wide windows in place of taller narrow ones. Large porches have also been added and dormers or roof lights in prominent roof slopes. There are also instances where buildings have been extended in a manner which does not reflect the traditional design of the area's buildings, or that uses non-traditional construction materials. All of these have the effect of detracting from the original character of the buildings.
